BATES COLLEGE

THE THRILL OF THE CHASE

BY DOUG HUBLEY

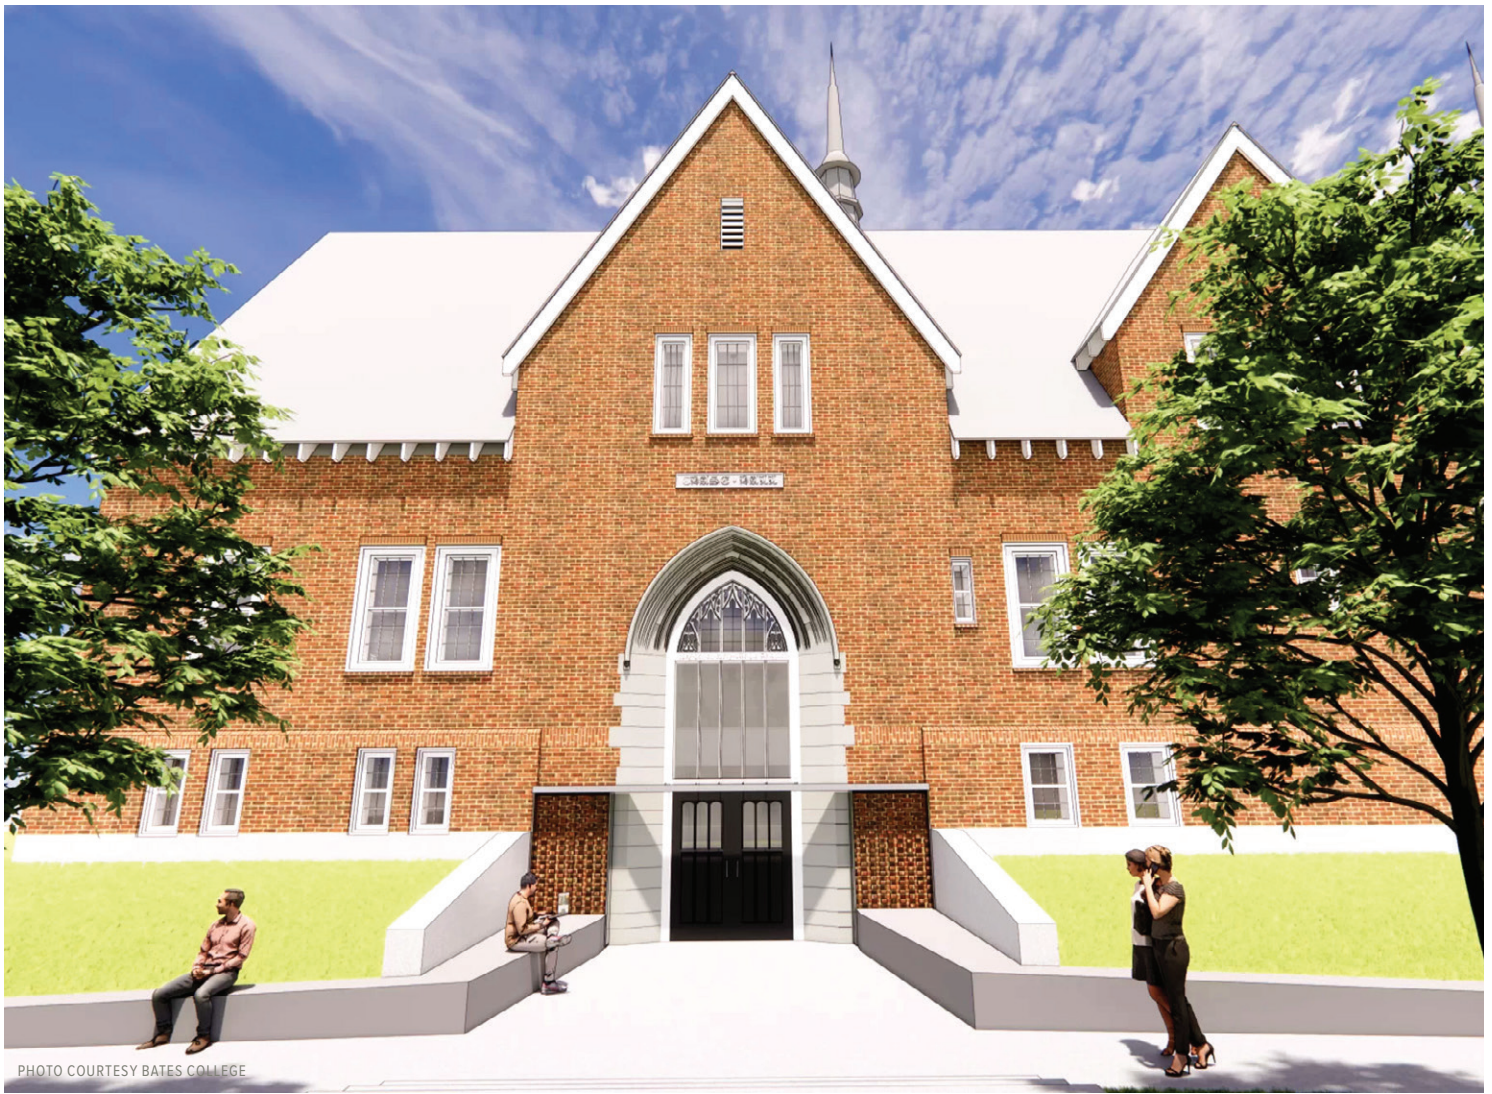
The discovery of the need for joist remediation shows how the whack-a-mole nature of exigency response in the Chase project has caused some shuffling of timetables.

One of the last of several surprises that lent the Chase project such a thrill-ride quality appeared in September. Wooden floors in the building are supported by joists whose ends rest in notches in the interior brick wall. Demolition in Chase Hall Lounge, though, revealed that the ends of a number of joists overhead had been sawed off, denying them contact with the joist pockets in the brick. The precise motivation for removing the joist ends isn't known, but that work was done adjacent to windows. It's believed that incoming moisture, whether because the window units failed or someone failed to close them, rotted the joists.

To compensate for the lost support, the cut ends were fastened together with additional pieces of lumber, serving as ledger boards. These in turn were attached to the brick wall, but this arrangement didn't provide

the same quality of support as the original construction. That change created some saggy spots on the second floor, but baseboard heaters concealed the cause of the droopiness until their removal during demo.

The fix, Mynhier explained, entailed removing interior brick where joist pockets once were, connecting the truncated joist ends to the exterior layer of brick with metal "ties," and then rebuilding the interior wall. (In cross-section, the wall in question consists of a double exterior layer and a single interior layer, separated by an air gap.) She said that "It's probably been about a month from initial discovery of the problem to having the engineer look at it, bringing the abatement contractor back to do the Chase Lounge ceiling, and then having the engineer finalize the plan" for repair.
